# Manhole Inspection Summary

Manhole # S17GG2018MH

Insp Date: **10/9/06 1:26 PM**

**Location** Address: **5920 SMITH AVE**

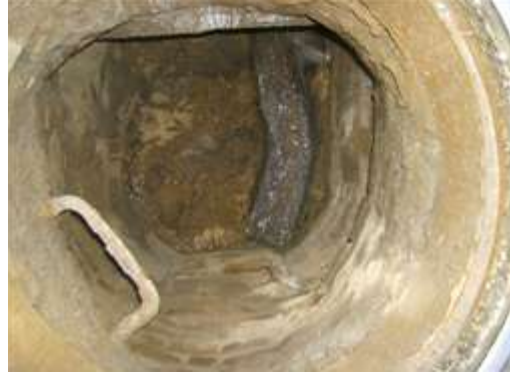
Top View

Count: **2**

Missing: **1**

☒ **Corroded**

☒ **Evidence Of Surcharge**

Corroded and missing steps. Evidence of surcharge - Bench debris.

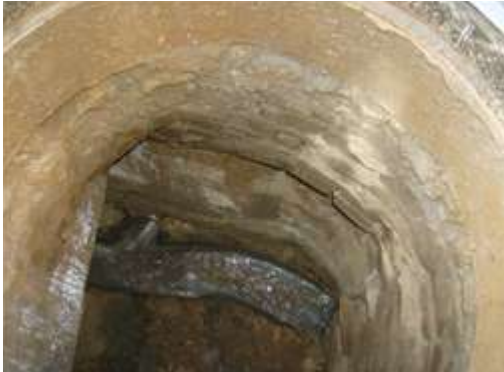
Defect

☒ **Leaks**

Condition: ☐ Sound ☐ Cracked ☐ Root Intrusion ☐ Loose Brick ☒ **Deteriorated**

Infiltration: ☐ None ☒ **Joint** ☐ Cracks ☐ Mortar ☐ Roots ☒ **Wall**

Infiltration: ☐ None ☐ Joint ☐ Cracks ☒ **Mortar** ☐ Roots ☒ **Wall**

Frame leaks. Adjustment deterioration and infiltration. Barrel infiltration - other side.

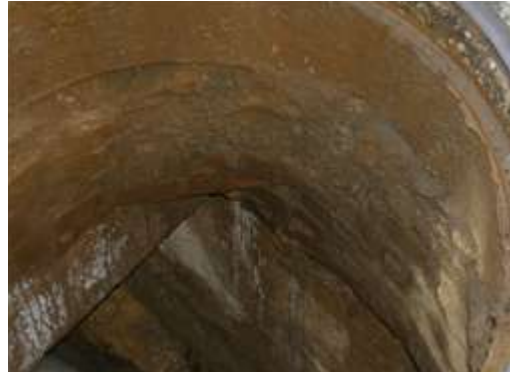
Defect

Frame leaks. Adjustment deterioration and infiltration. Barrel infiltration.

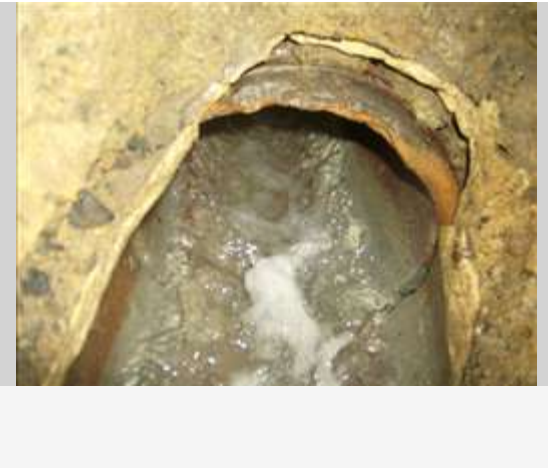
8 in. Circular Gravity Sewer

Infiltration: **Evidence**

Pipe Seal Cond: **Broken**
